**Dragonchip**

# Software Development Notice for DC6388F

AppNote200

Document Revision 1.6

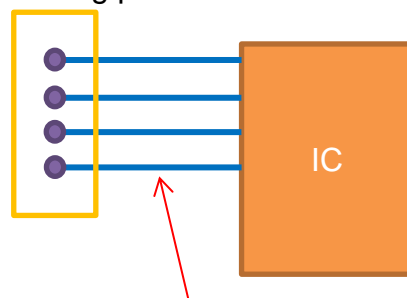
Programming pads

No carbon film between pin and pad, and length < 3cm
